Accident Study and Improvement Plan

VALLEY COUNTY ACCIDENT STUDY
AND IMPROVEMENT PLAN

MONTANA ASSOCIATION OF COUNTIES

CLETE DAILY AND ASSOCIATES
524 West Lawrence
Helena, Montana

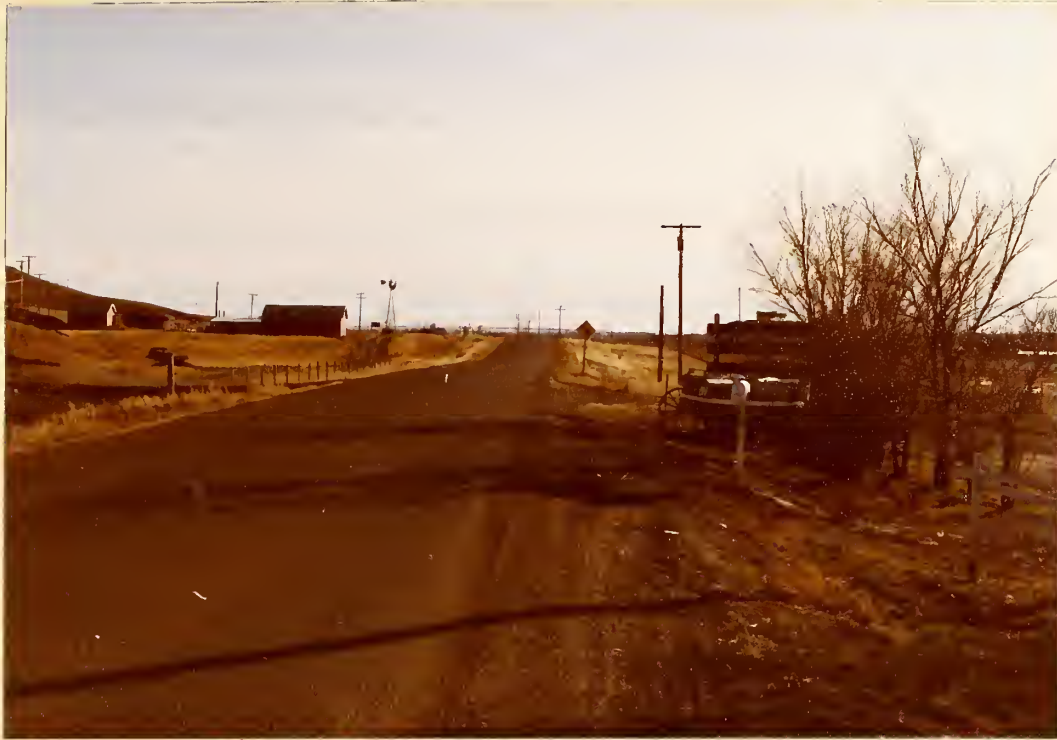
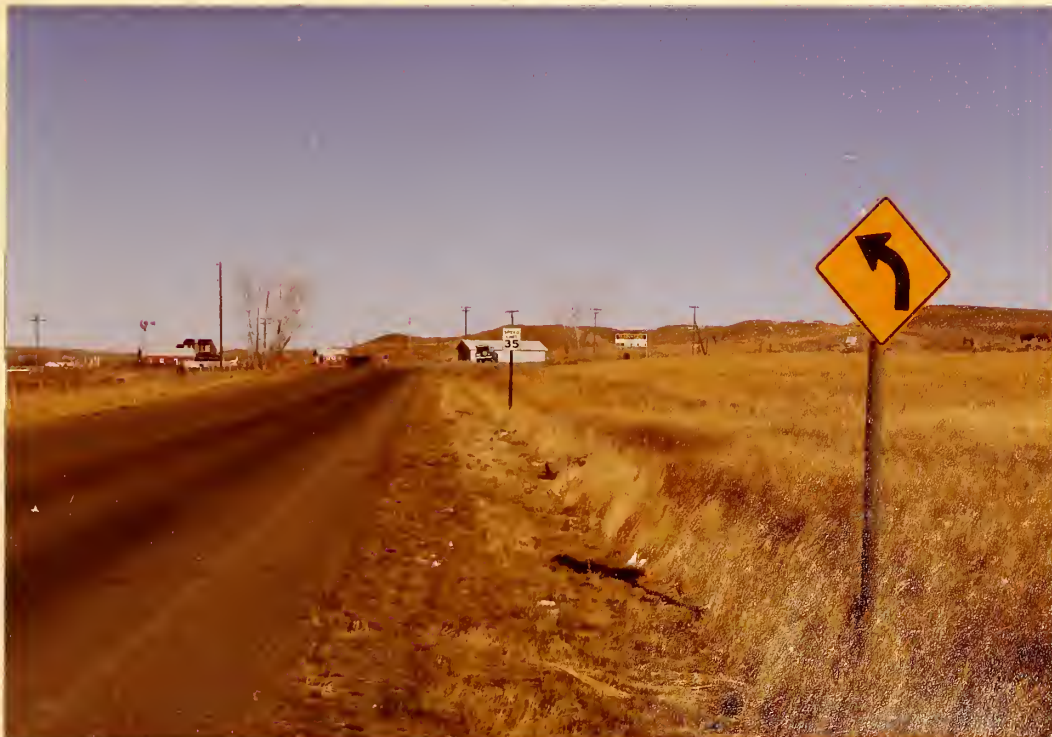
SITE #2

North Approach

South Approach

A total of four accidents occurred at this location from 1979 through 1982. Three of the accidents occurred during the winter during icy road conditions. All accidents happened during daylight hours with three involving collisions between two vehicles and the other, a motorcycle accident resulting in a fatality, was due to loss of control and excessive speed. Accident diagrams are shown on Figure 2-1. Accident characteristics are summarized in Table 2-1.

1. Replace the existing 30-inch X 30-inch W1-2L (left curve) sign on the south approach with a 30-inch X 30-inch W1-4L reverse curve left sign.
2. Install a 24-inch X 24-inch R1-1 STOP sign on the approach of the landfill access road.
3. Install delineators on the curves spaced as shown feet on the curve.
4. Install a 35 MPH advisory speed plate on the existing 30-inch X 30-inch W1-4R reverse right curve sign on the north approach.
5. Restrip centerline and shoulder stripes.
6. Sand both curves during icy conditions.

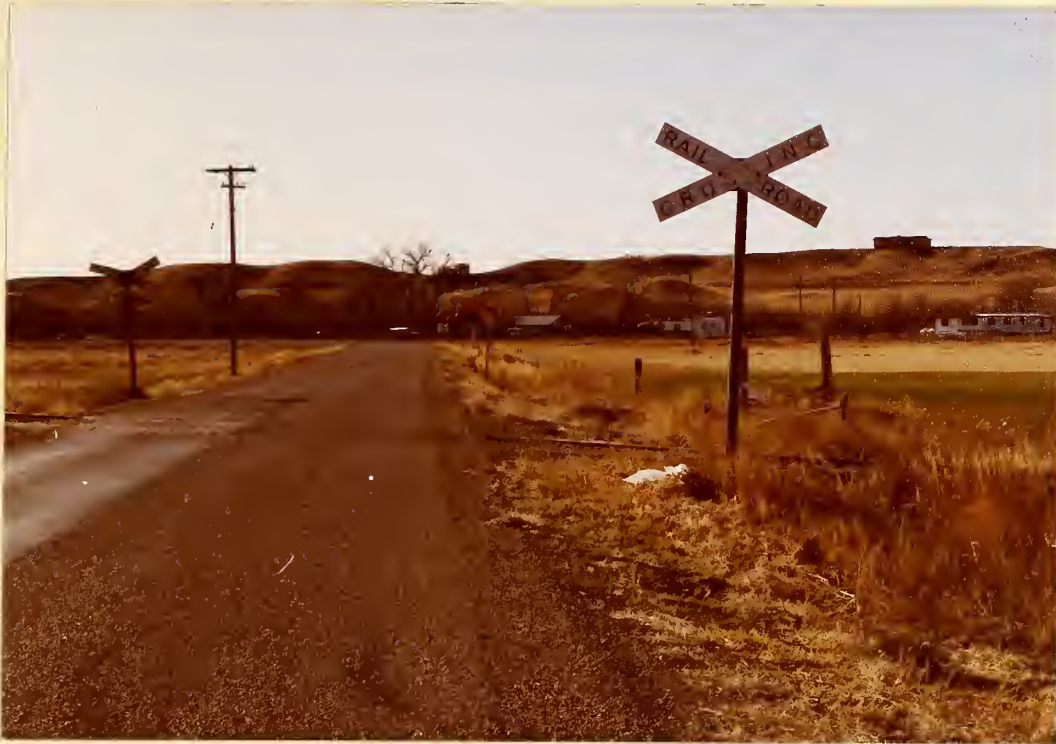
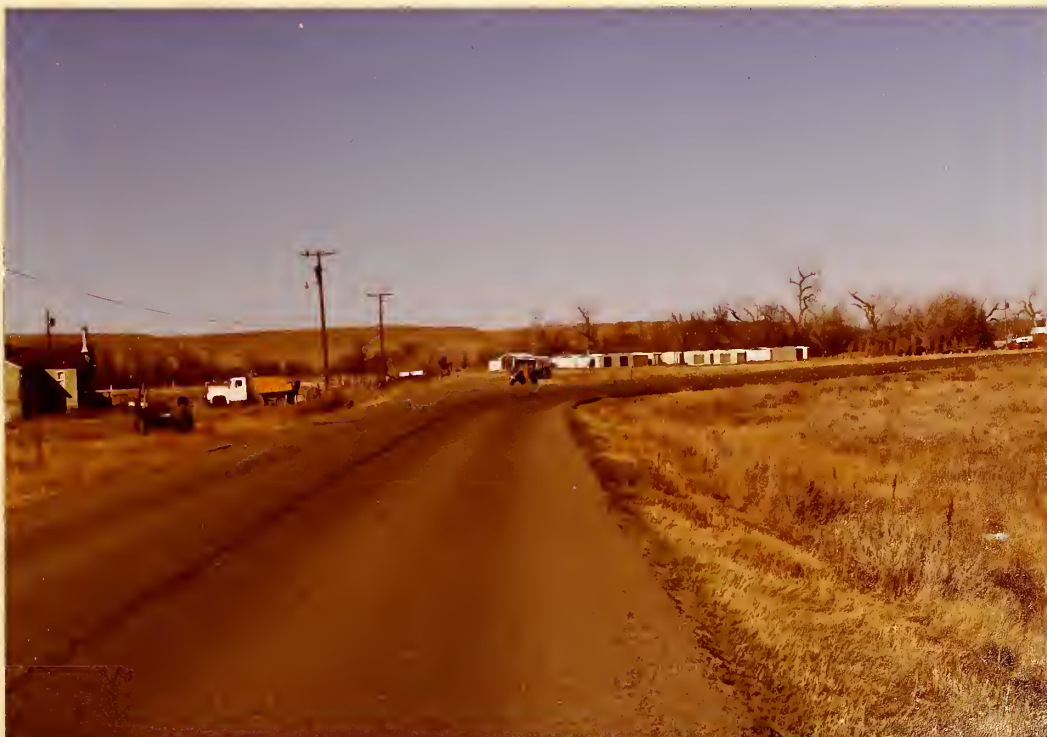
SITE #3

Northeast Approach

South Approach

1. Field observations indicate excessive speeds in this area.
2. A background roadway showing from the south approach could cause a driver to perceive a straight road.
3. Shoulder and centerline striping has been worn off.

1. Install delineators spaced as shown feet on curve.
2. Install 18-inch X 18-inch W13-1, 35 MPH speed advisory plates on existing curve signs on the south and east approaches.
3. Install 48-inch X 24-inch W1-6L near P.I. of curve in line with the westbound approach.
4. Install 48-inch X 24-inch W1-6R near P.I. of curve in line with the northbound approach.
5. Restripe centerline and shoulder stripes.
6. Sand during icy conditions.

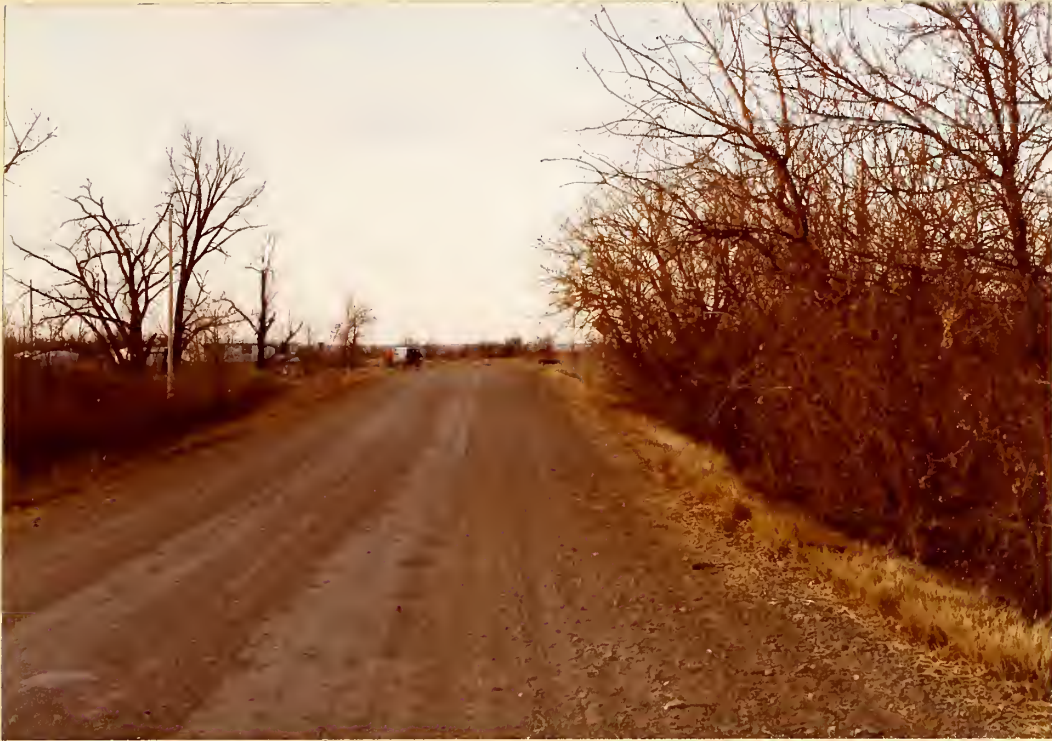
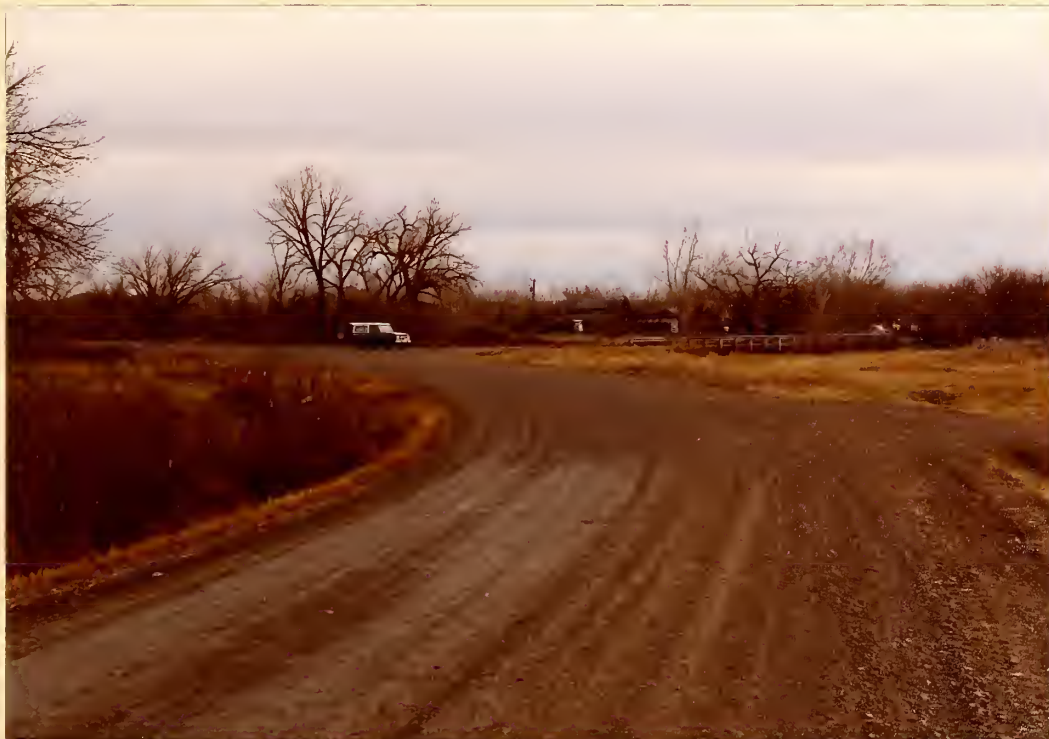
SITE #4
MAHAN AND HOYT RESERVOIR ROAD

North Approach

South Approach

The road has a gravel surface. Traffic on the road includes travel to and from farms in the area, farm to market travel and recreational travel by fishermen and hunters. The average daily traffic is estimated to be 300 vpd on the north leg, 230 vpd on the south leg and 70 vpd on the east leg. Figure 4-1 shows existing conditions.

The recommended improvements are shown on Figure 4-2.

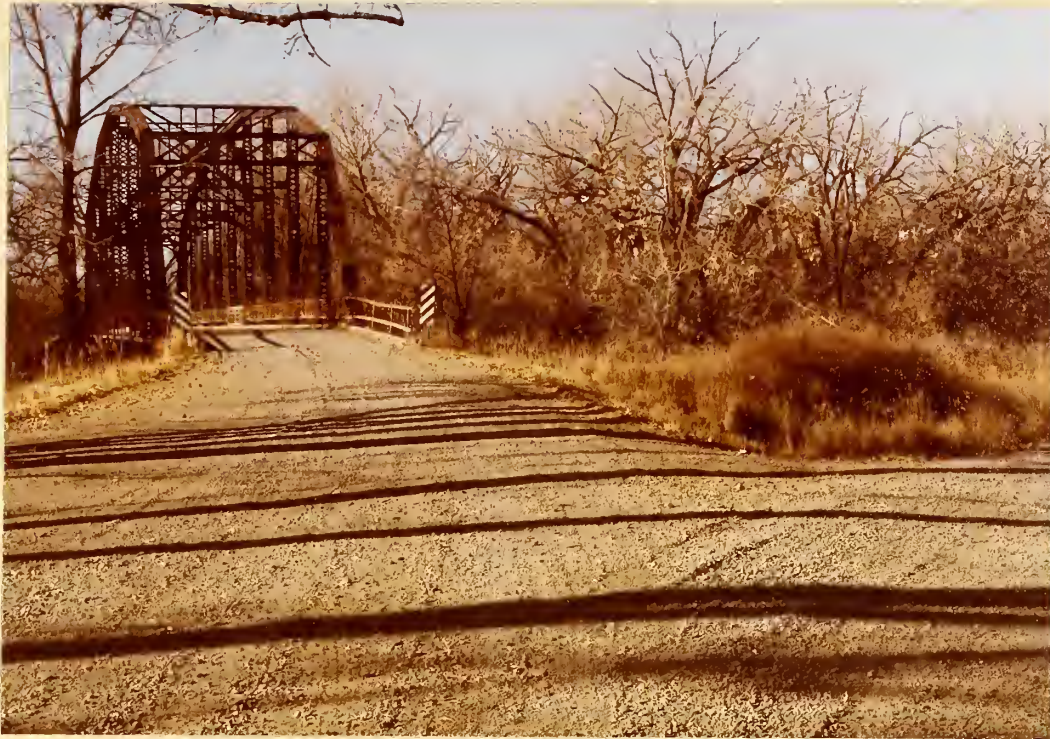
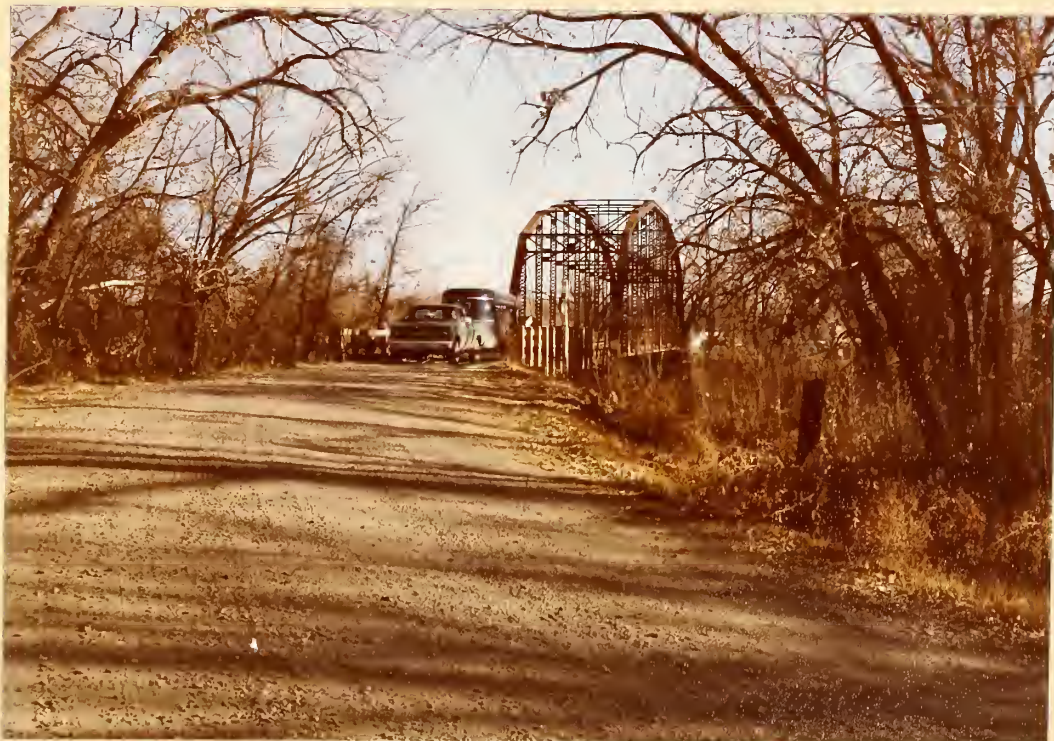
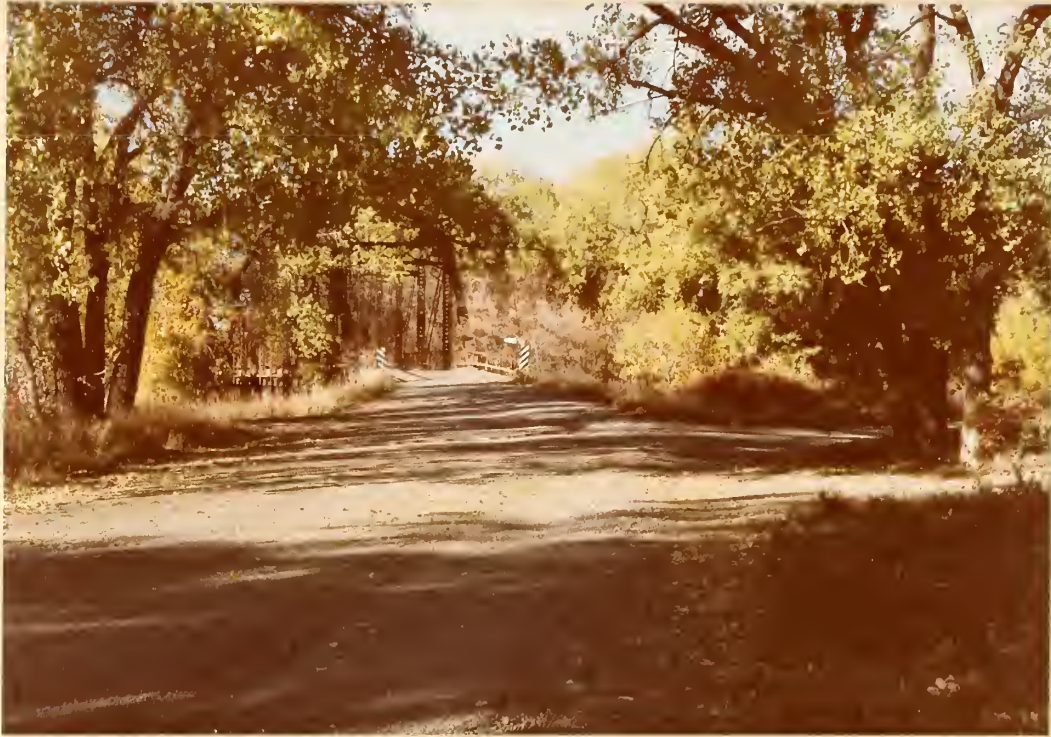
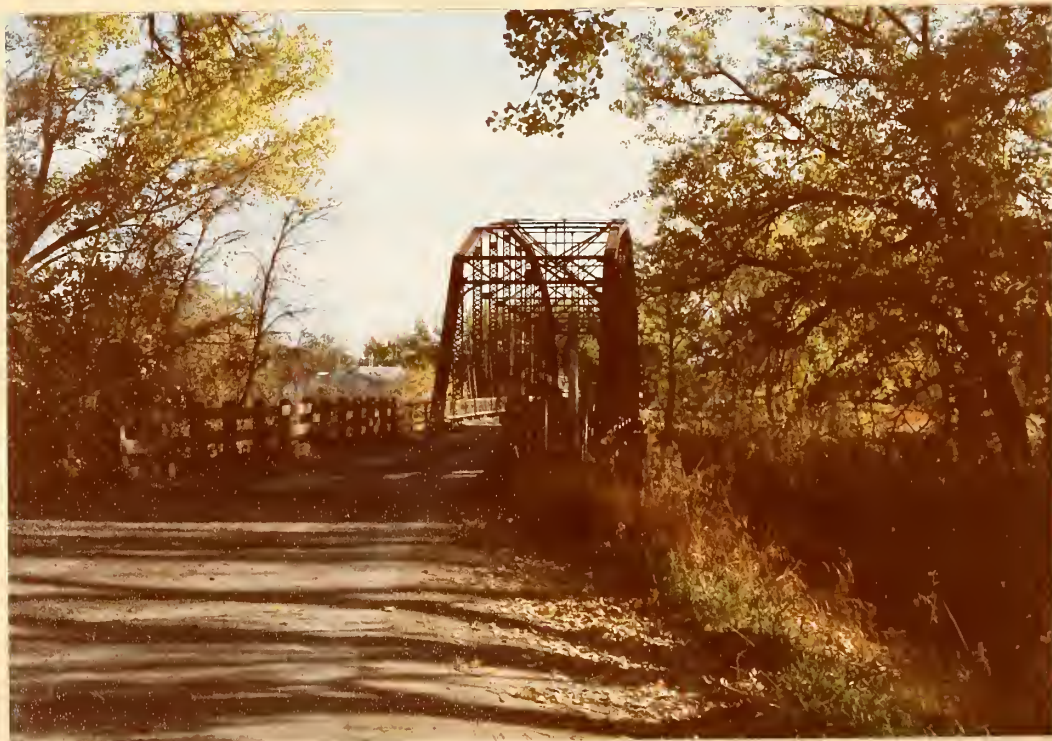
SITE #5
6TH AVENUE BRIDGE -- GLASGOW

East Approach (Winter)

West Approach (Winter)

East Approach (Fall)

West Approach (Fall)

1. Replace existing 30-inch X 30-inch W1-1R turn sign on west approach with a 30-inch X 30-inch W1-2R curve sign.
2. Add a 30-inch X 30-inch W1-2L curve sign to Narrow Bridge Sign on east approach.
3. Replace existing guard rail with standard guard rail with rounded ends on east approach. Relocate bridge and hazard markers.
4. Lower wooden guard rail on west approach to standard height and supplement with standard guard rail.
5. Clear brush and trees on south side of west approach.
6. Install 11T-16T-22T, 30-inch X 30-inch, R12-5 bridge weight limit sign at both approaches.

1. Replace bridge with a new structure -- cost to be determined by preliminary design.

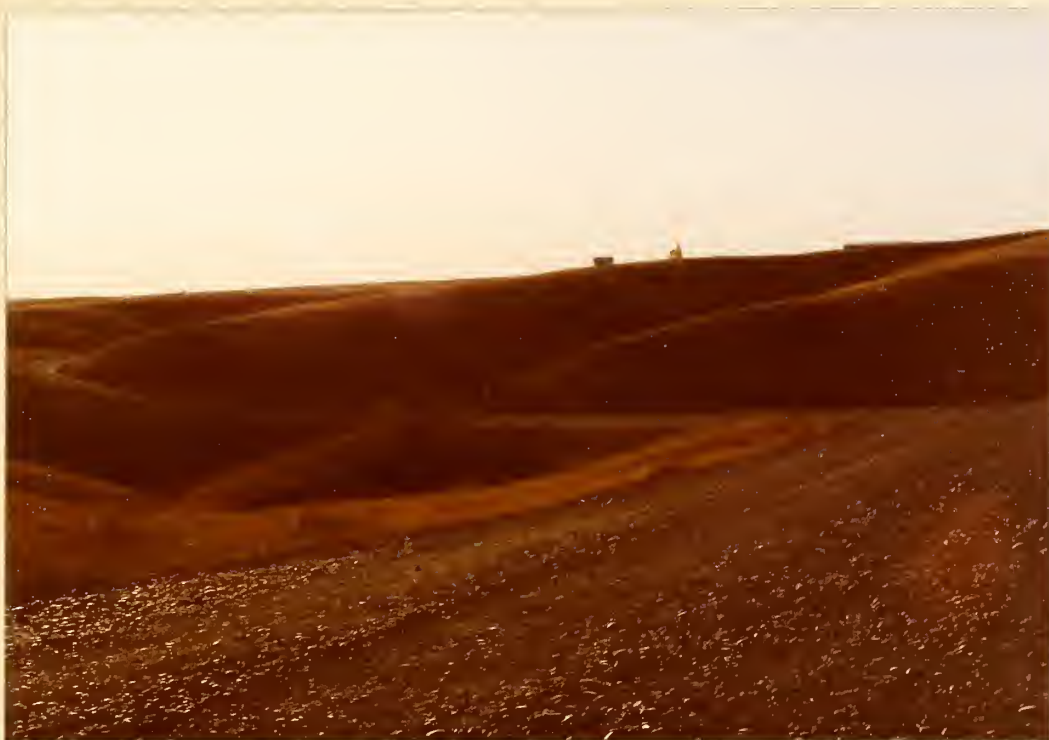
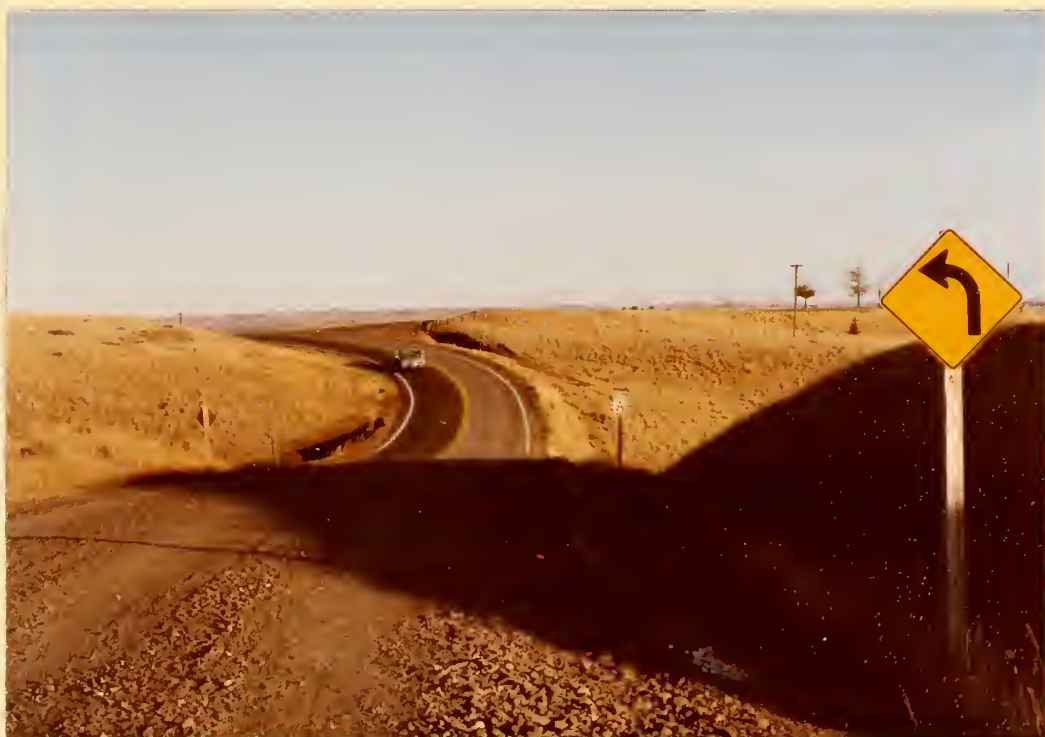
SITE #6
COTTAGE ROAD -- FORT PECK

West Approach

All of the accidents were the result of vehicles leaving the road. Speed was listed as a possible violation in five of the accidents.

1. Primary accident occurrence is due to vehicles leaving the road because of excessive speed.
2. Due to the east-west orientation of the site, dark and dusk light conditions contribute to poor roadway visibility (see photo).
3. Gravel portion of road develops washboarding because of grades and high seasonal traffic volumes.
4. Recreation traffic to/from the areas served by the road has a high number of younger drivers which statewide statistics show, have a higher accident rate.

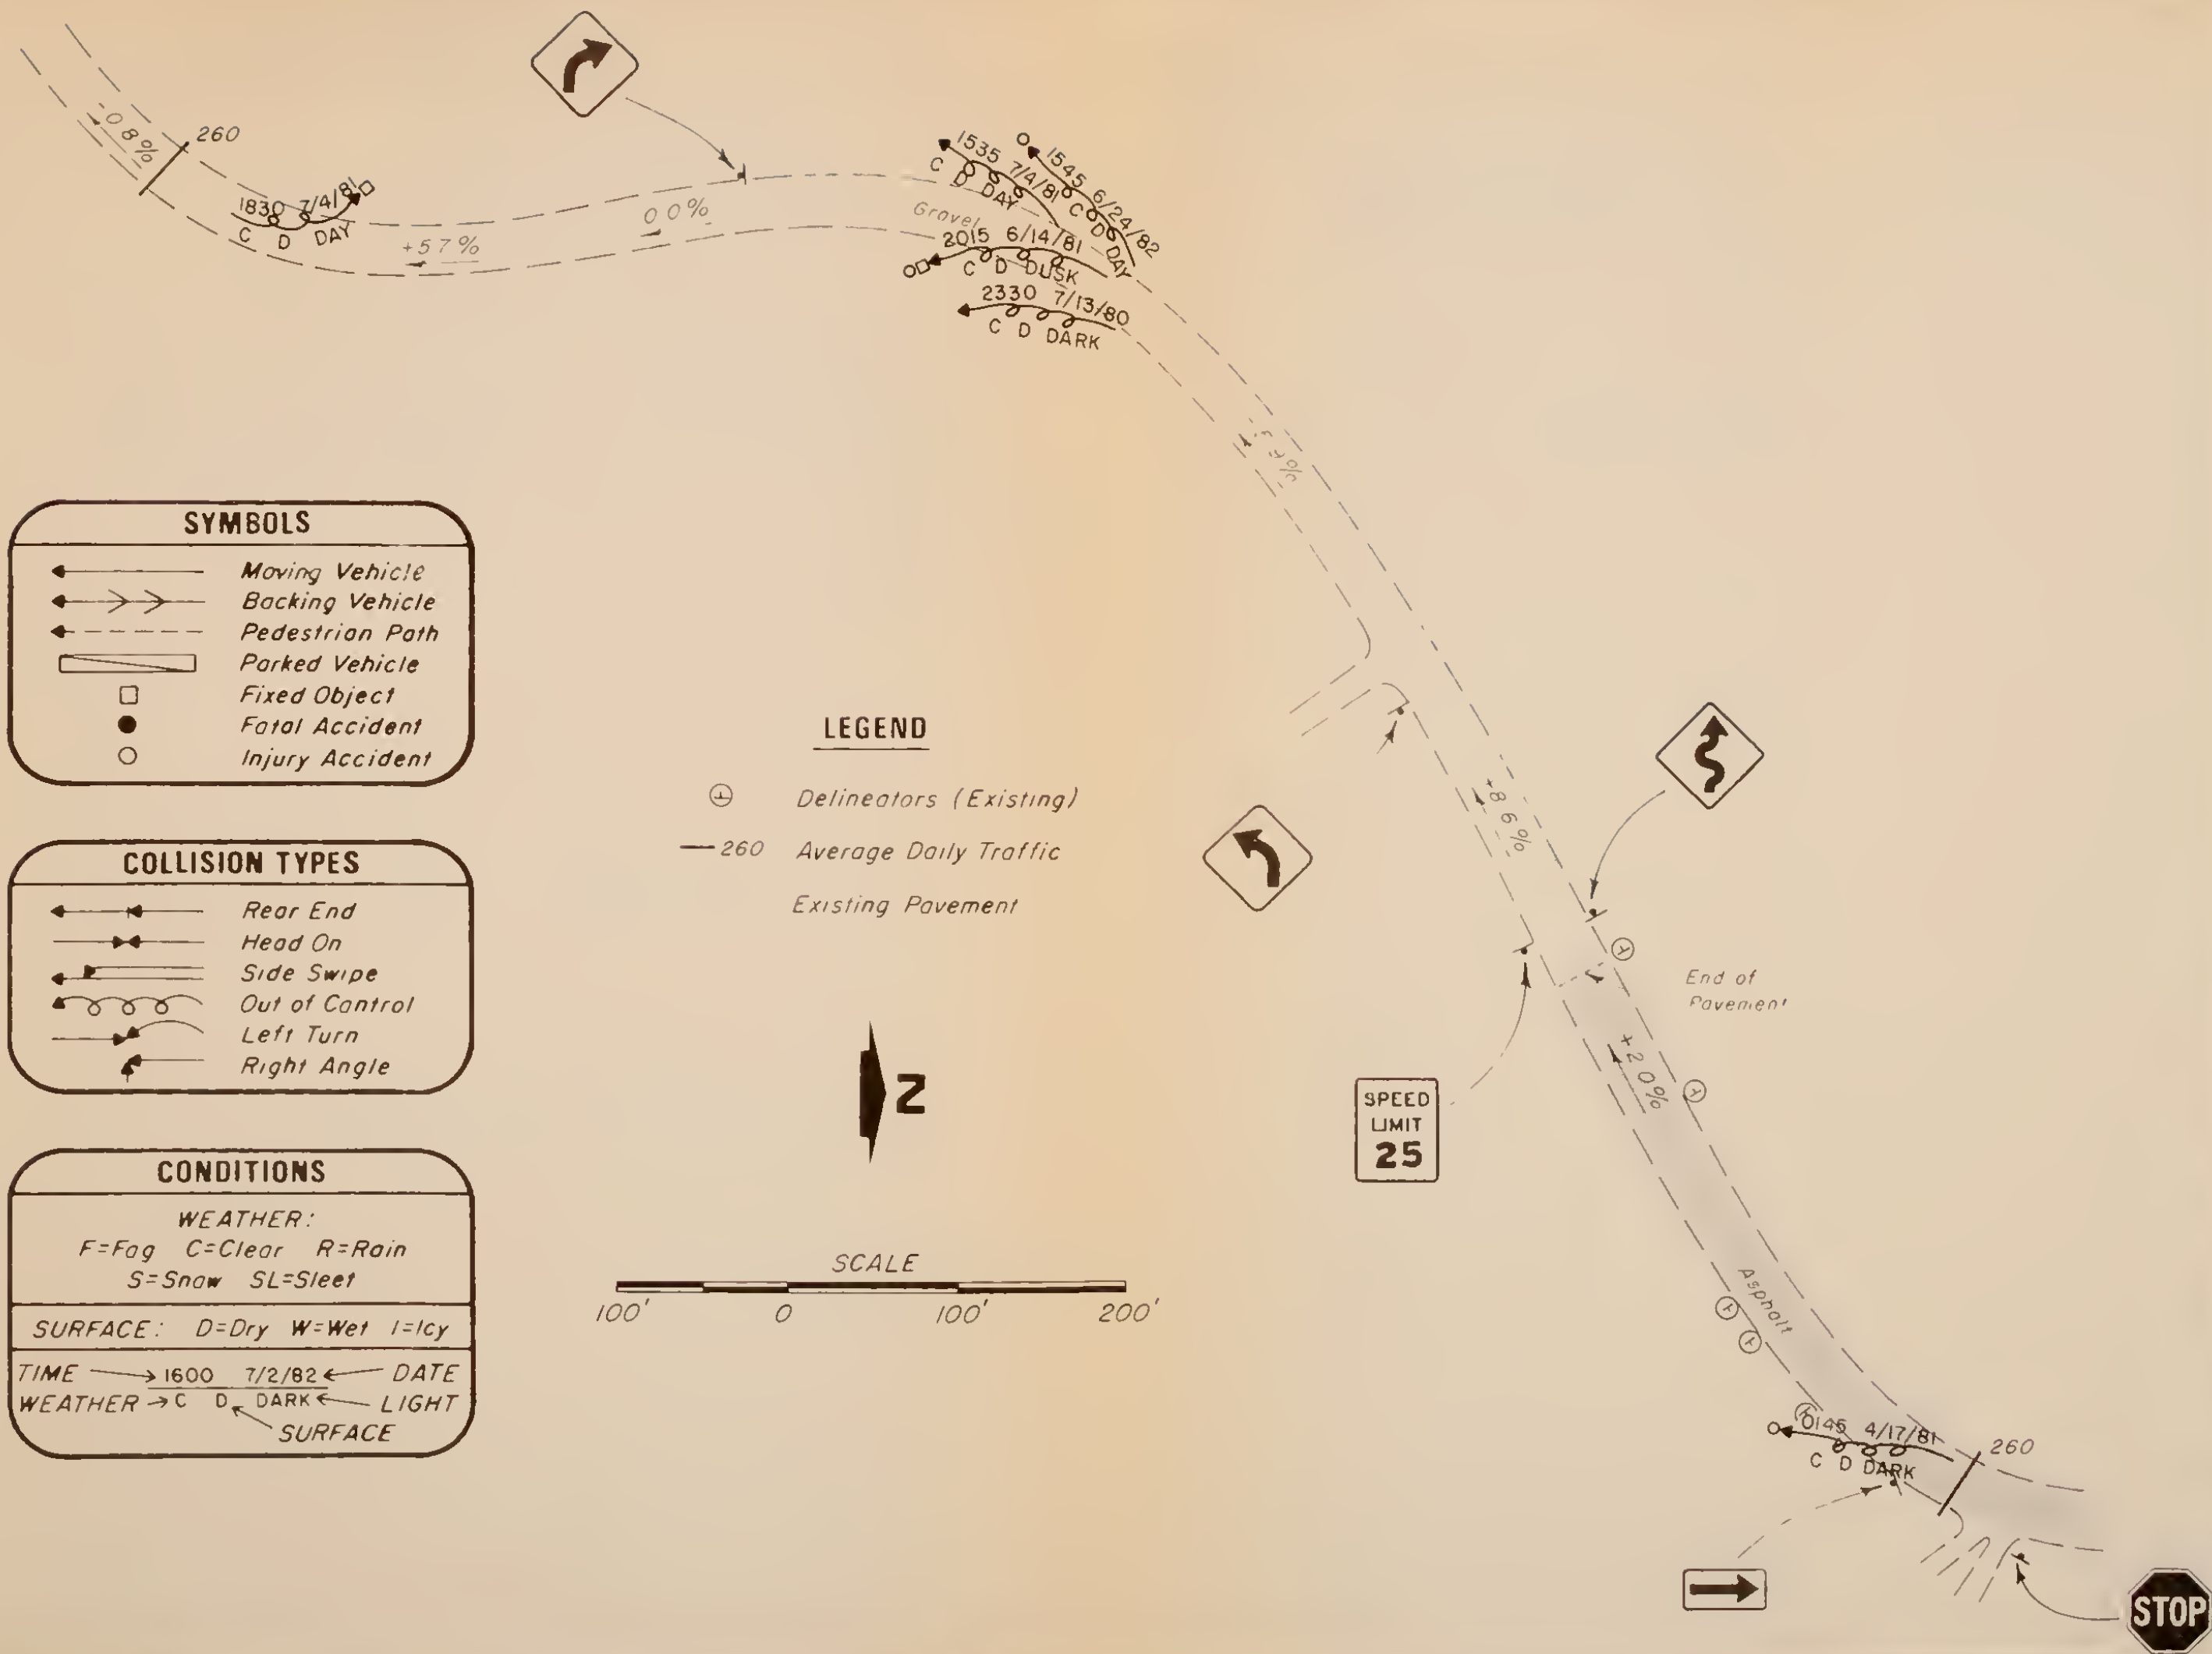
6-1

Existing Conditions & Accidents

Collage Road - Fort Peck
